Lake Powell Pipeline

Draft Study Report 20 Wetlands and Riparian Resources

March 2011

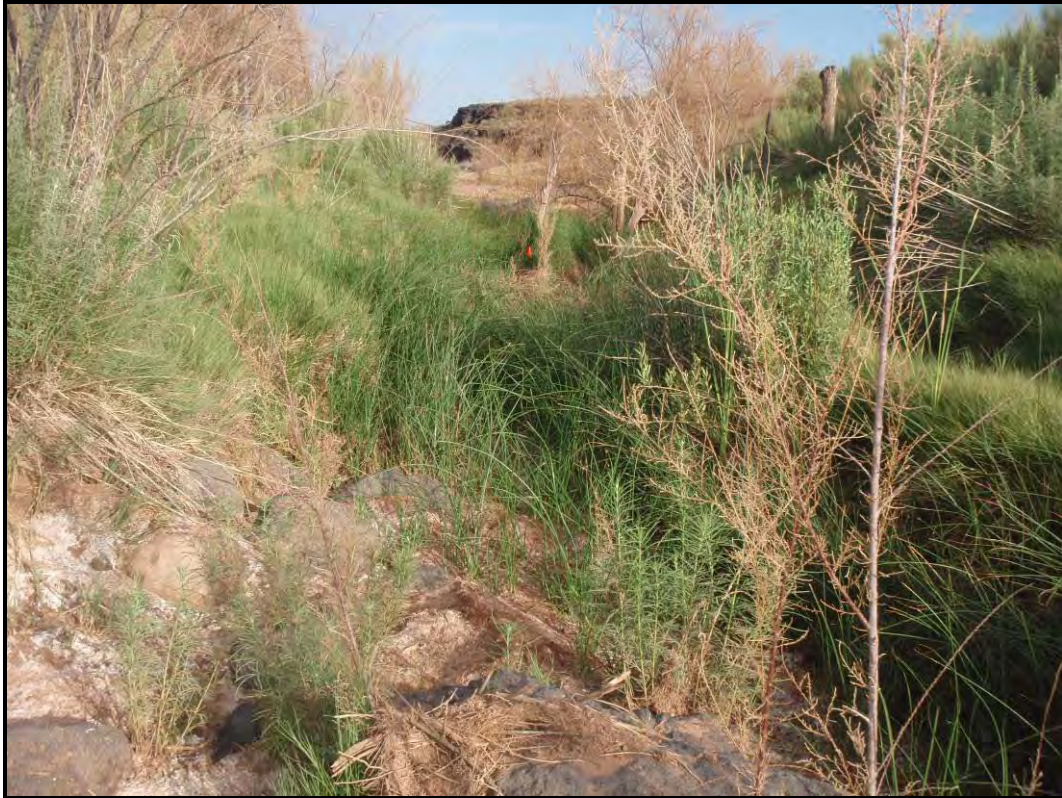
Gould Wash Wetland

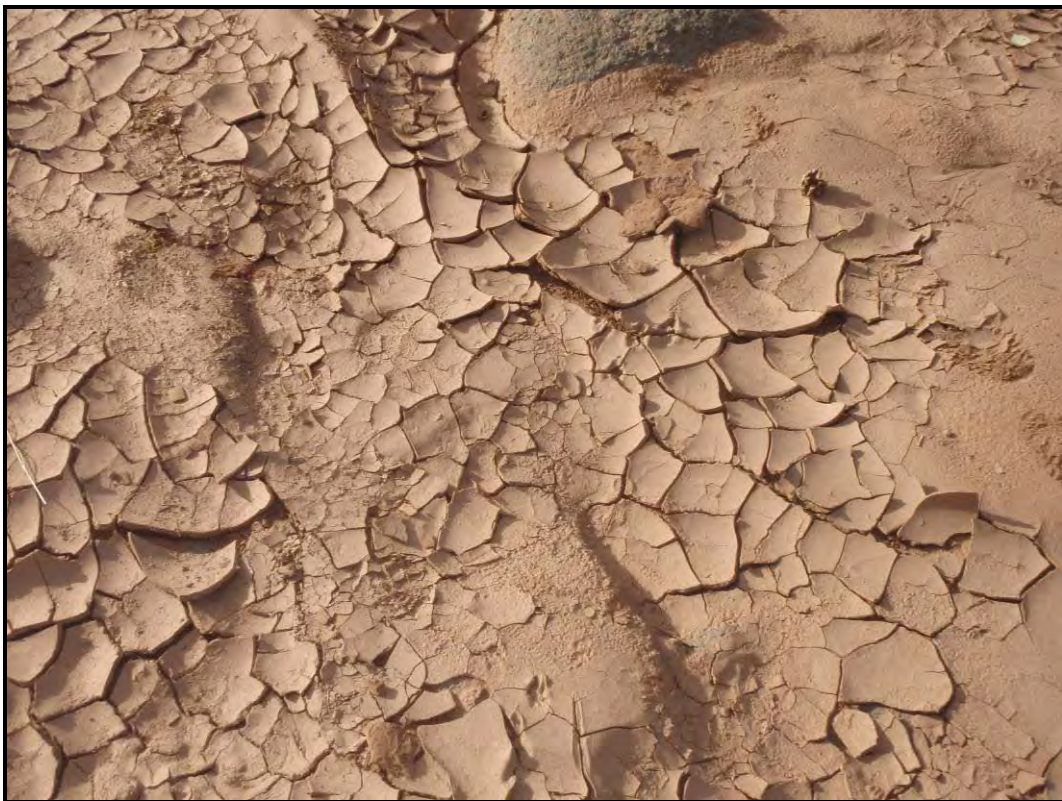
Soil cracking in Gould Wash

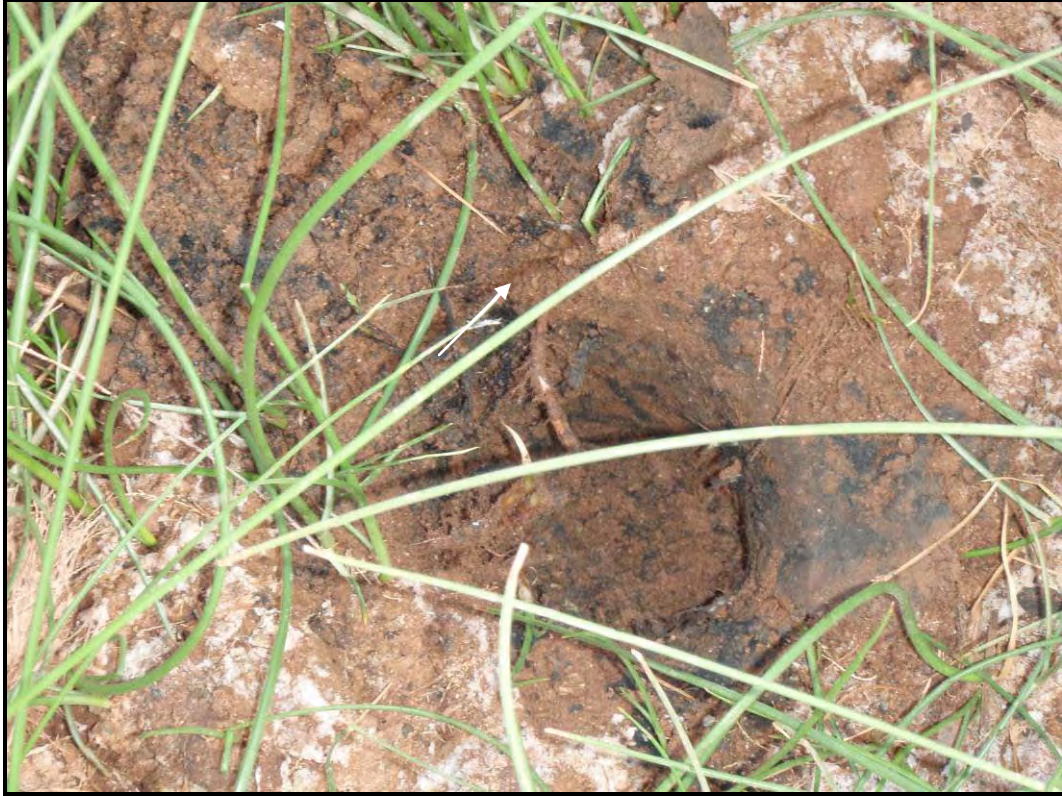
Soil pit (SP1) and salt deposits at Gould Wash Wetland
